## **Limited Visual Dam Safety Inspection Summary Report**

**MA-077**

**Reservoir 40**

Limited Visual Dam Safety Inspection Conducted on: 04 April 2006

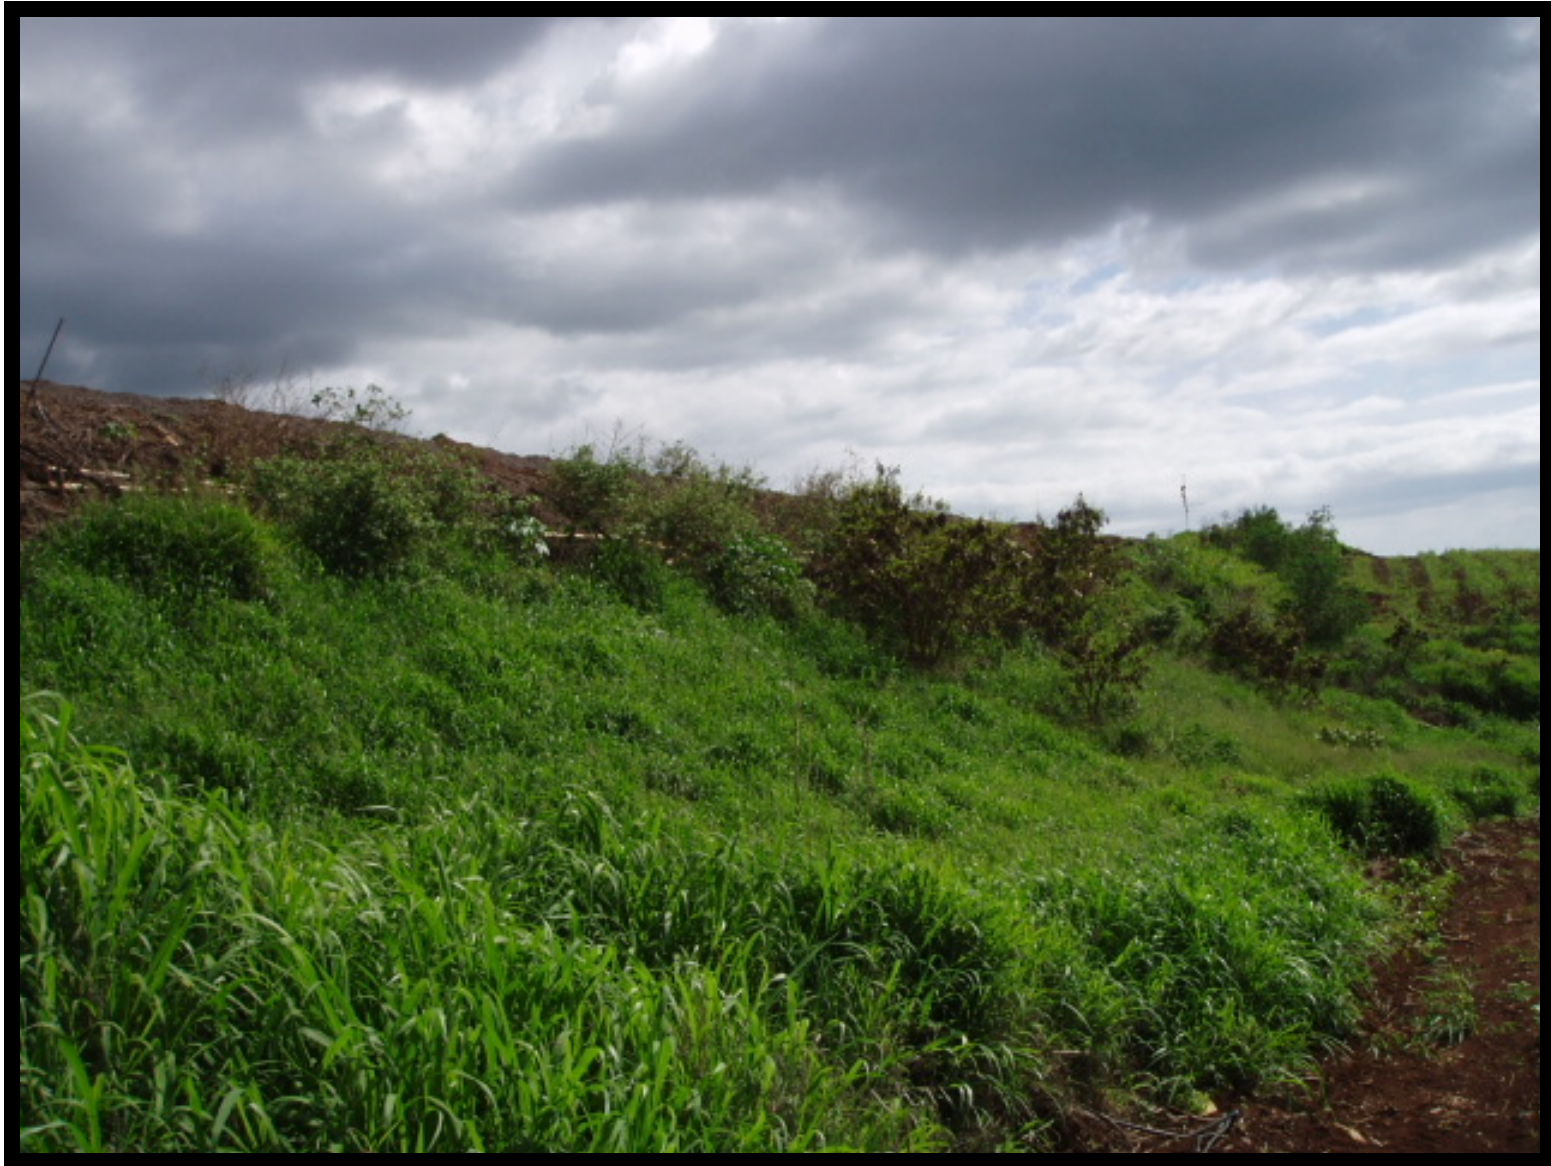
The downstream slope was approximately 1 on 1.  
Some areas of the slope had dense vegetation, so inspection was difficult.

- a. The downstream slope appeared to be in fair to poor condition and requires corrective action.
- b. The down stream slope was not visible due to high grass and bush vegetation. Clear high vegetation and maintain low to enable easy visual inspection.
- c. Tree(s) were observed on the downstream slope. Trees have been identified as the probable cause of piping failures, and can possibly cause severe damage to the embankment if they are uprooted during high winds. Corrective action is required to remove the tree hazards from the dam. Acceptable remedies include removal of the tree and its root structure down to a 2" diameter and reconstruction the damaged embankment section. All repair work shall be accomplished as per the requirements of licensed geotechnical or structural engineer. Routinely monitor the damaged area for signs of settlement and seepage.

- d. The slope was very steep, around a 1 to 1 slope; further study is required to verify slope stability.

077 downstream slope of the dam

The owner should continue with periodic removal of underbrush and trees from the embankment. Grasses should be kept short.

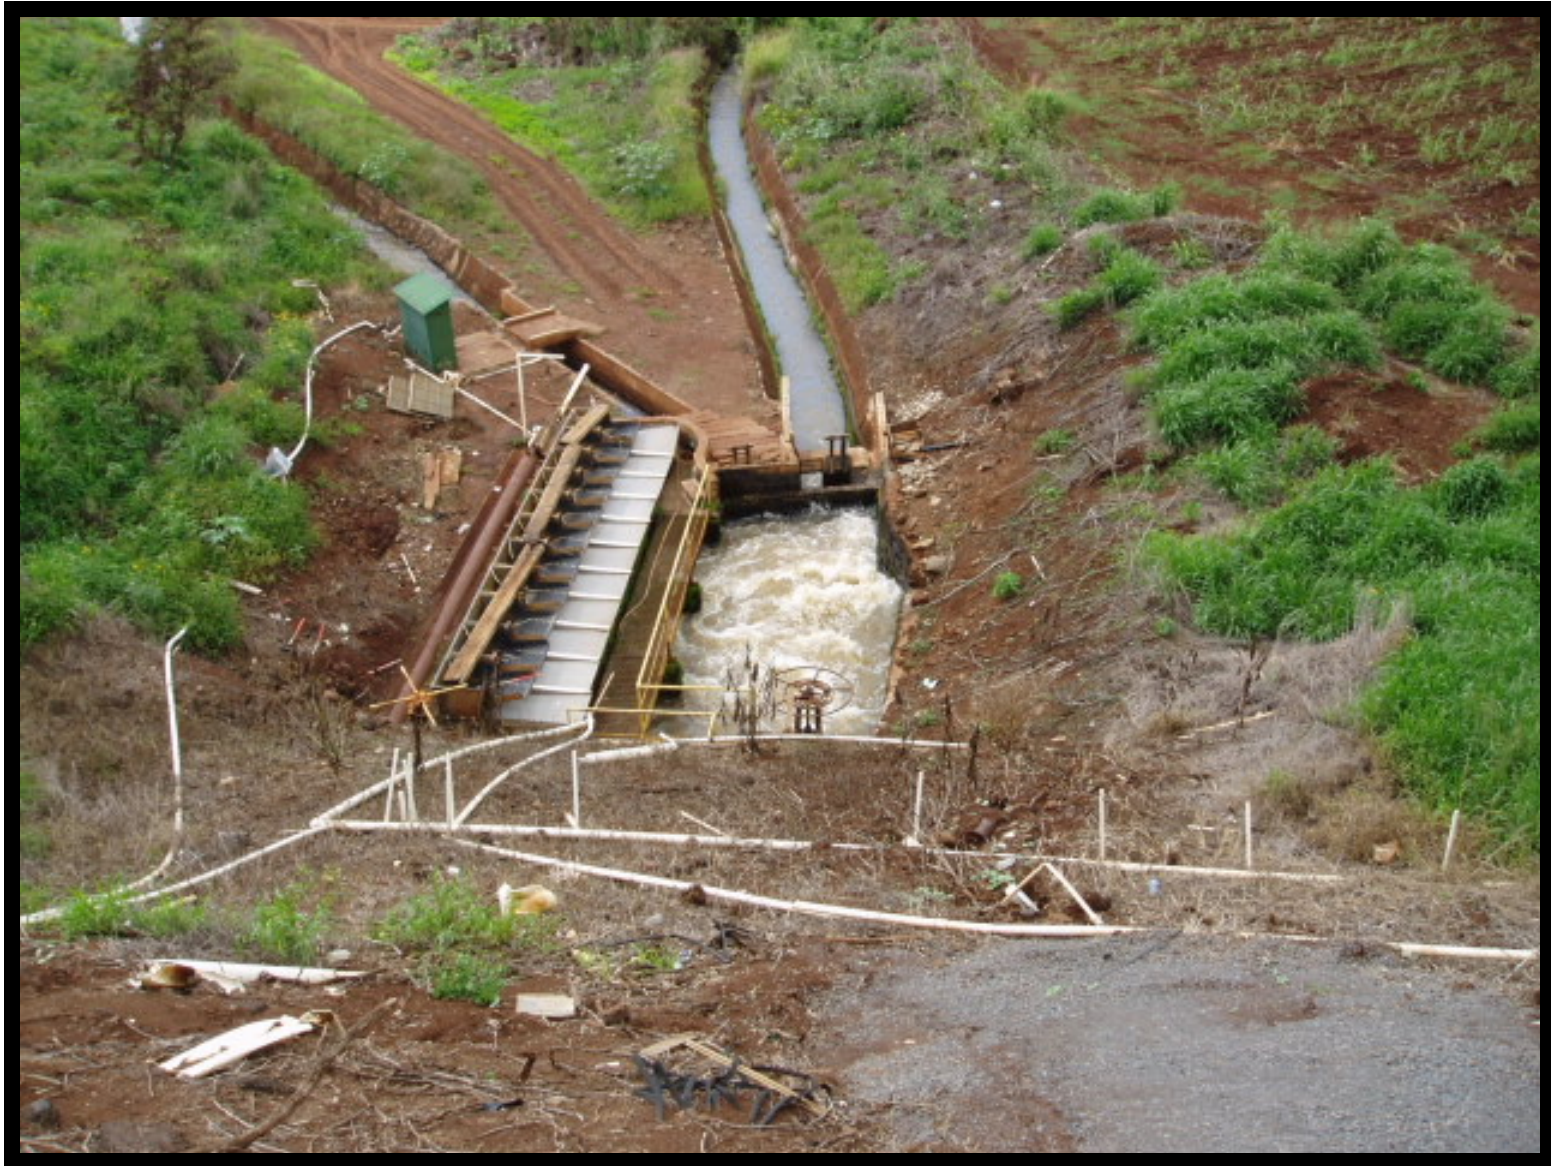
The outlet pipe has a 24" diameter steel pipe.  
The control of the outlet is with a valve that is on the downstream side.

- a. The outlet works were not tested.
- b. The outlet works appeared to be in satisfactory condition, no corrective actions are required at this time.

077 outlet

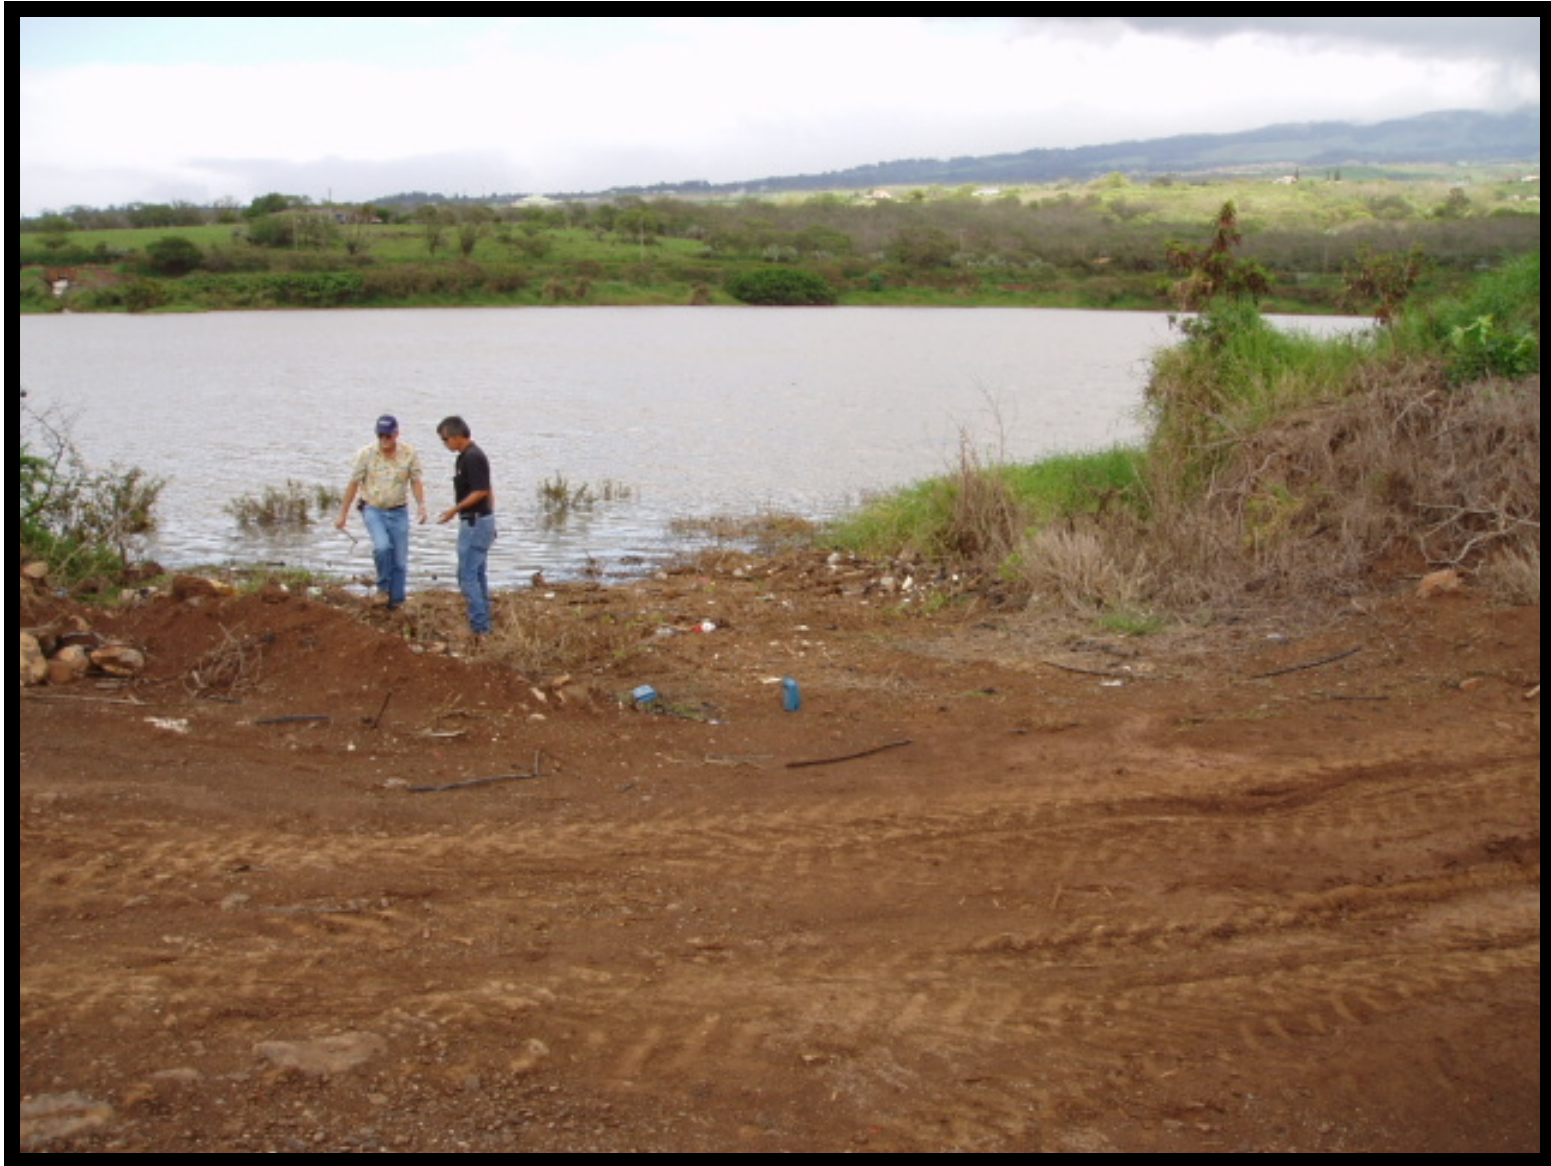
This spillway is consisted of a channel on the left abutment.  
The dimension is 25 feet and the invert elevation is 1040 feet NGVD.  
The spillway approach was clear.  
Erosion was not observed at the time of inspection.

- a. The Spillway appeared to be in satisfactory condition, no corrective actions are required at this time.

077 spillway

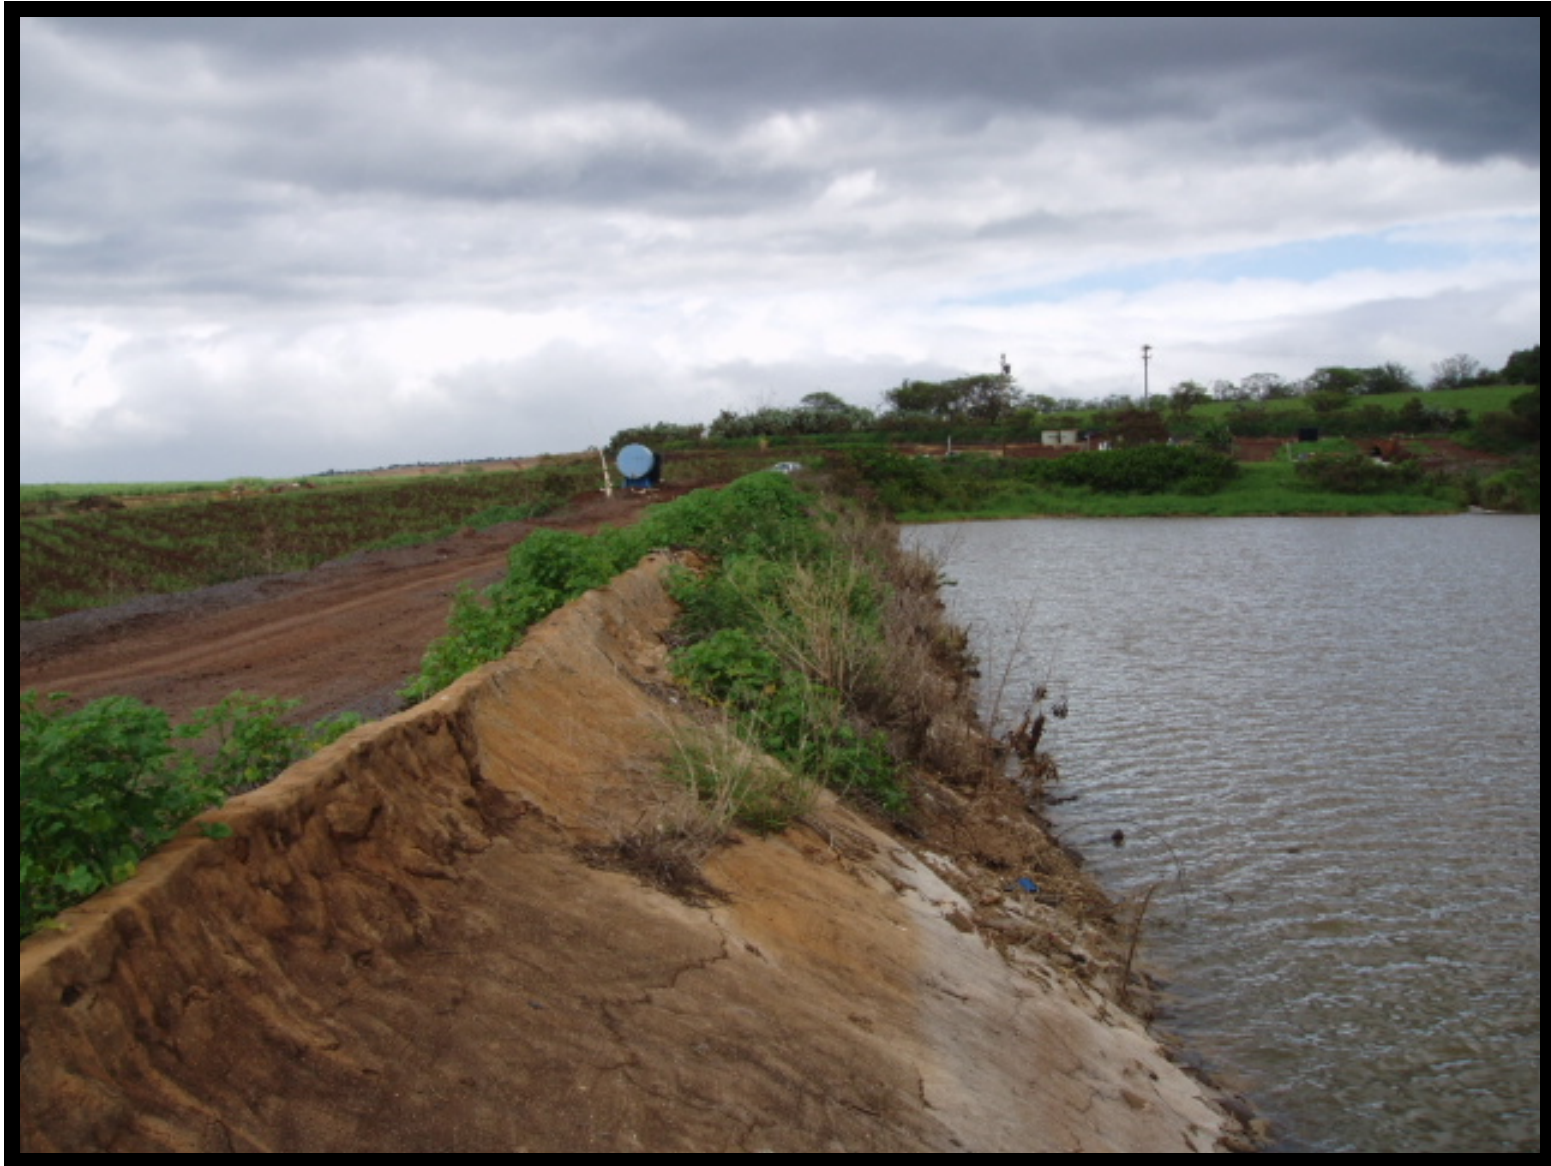
The upstream slope was 1 on 1 to 1 on 1.5.  
There were no erosion, cracks and sinkholes observed.  
The slope is protected with grouted riprap.  
The slope is practically clear of vegetation with only a few small shrubs.

- a. The upstream slope appeared to be in satisfactory condition, no corrective actions are required at this time.

077 upstream slope of the dam
